IN-DEPTH INSPECTION REPORT

ELEMENT SPECIFIC BRIDGE WORK

B.I.N. 1076620

FEATURE CARRIED Grand Central Parkway - Westbound C-D

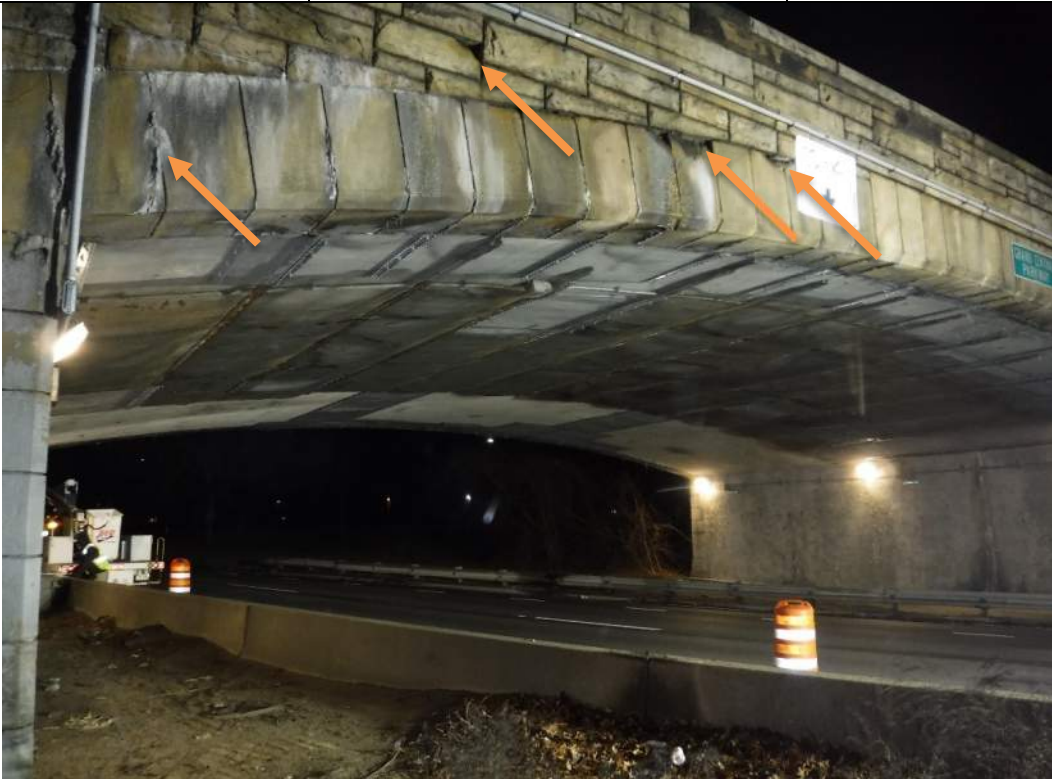
PHOTO: 1

Fascia: Both the North and South Fascia exhibit minor cracks and deterioration along the arch and ring stones. The North side exhibits missing pointing in the West side of fascia with active leaking around 1st ring stone from the Begin (West) Abutment and 4 LF missing pointing on the East side above ring stones 16-19 from the End (East) Abutment, exhibits multiple spalls up to 1 SF in the top of ring stones 9-12 from begin abutment and a 1.5 SF hollow area in ring stone 28 from End abutment. The South side exhibits missing pointing up to 3 LF with heavy efflorescence along the bottom of the arch, a large deterioration above the 6th ring stone from the Begin (West) Abutment, a 2 SF hollow area with active leaking above ring stone 9/10 from the Begin (West) Abutment. (See Photos 1-3)

LOCATION: West side of South Fascia
DESCRIPTION: Heavy efflorescence and 2 SF spall in ring stones
Looking Northeast

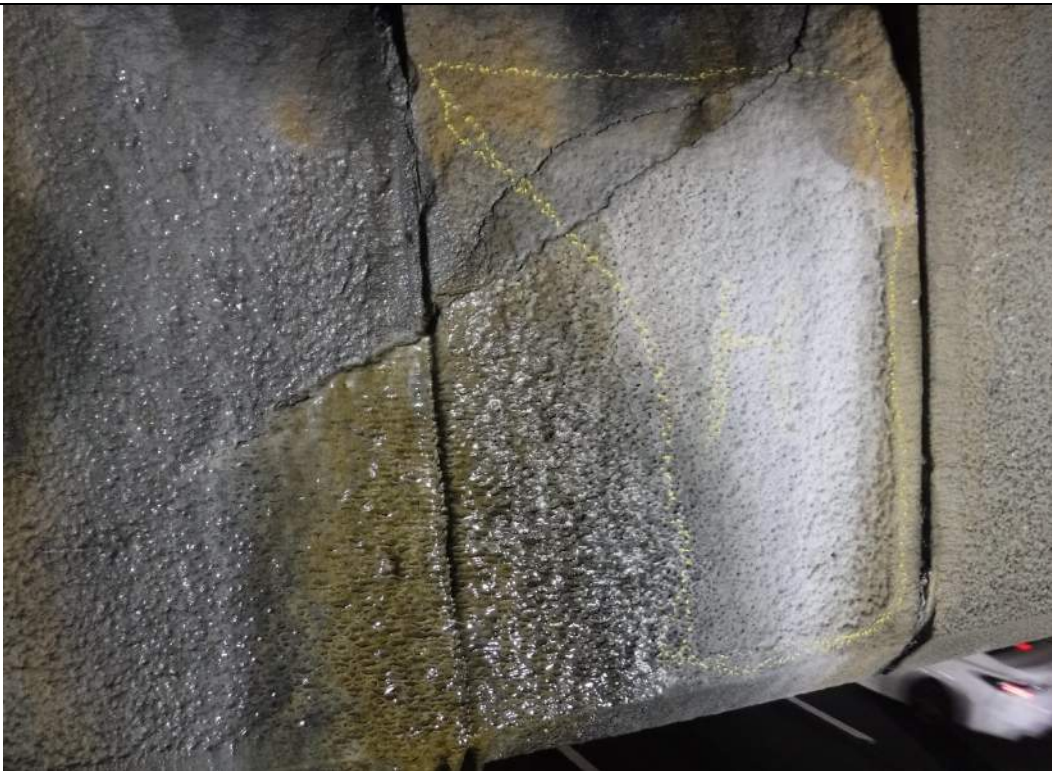
PHOTO: 2

LOCATION: South fascia ring stone 9 and 10 from Begin abutment
DESCRIPTION: 2 SF spall in top of ring stone with 2 SF hollow area on face
No loose concrete, Looking North

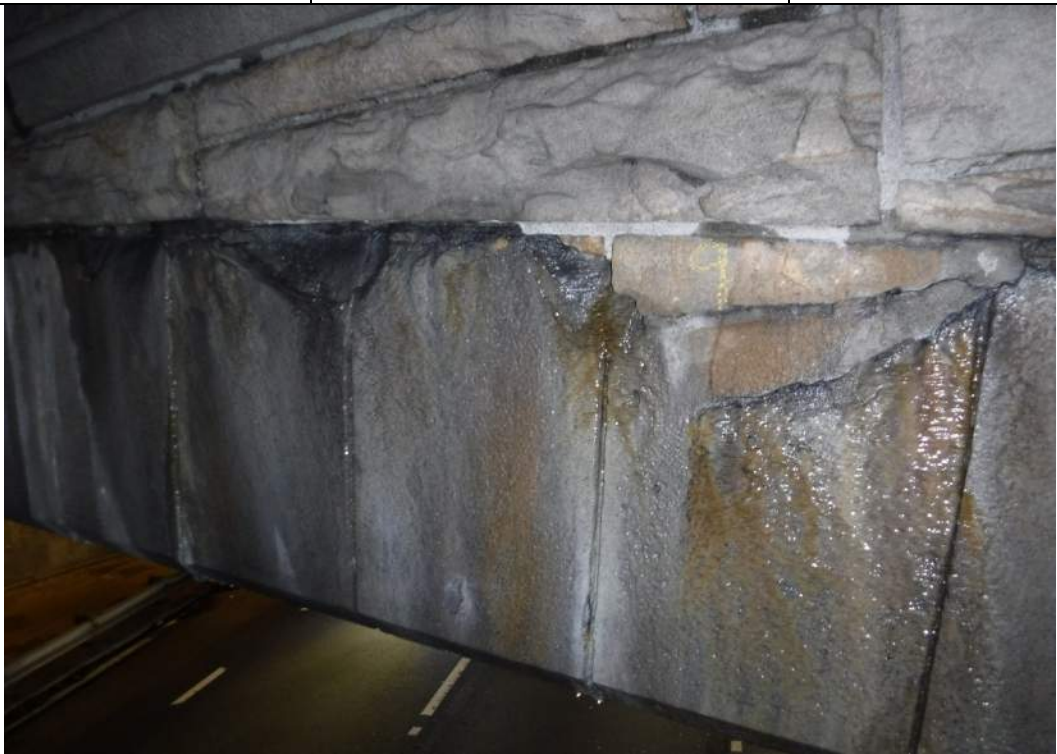
PHOTO: 3	LOCATION: North Fascia 9 th ring stone from Begin abutment DESCRIPTION: Multiple 1 SF spalls and cracking with active water leaking Looking Southeast

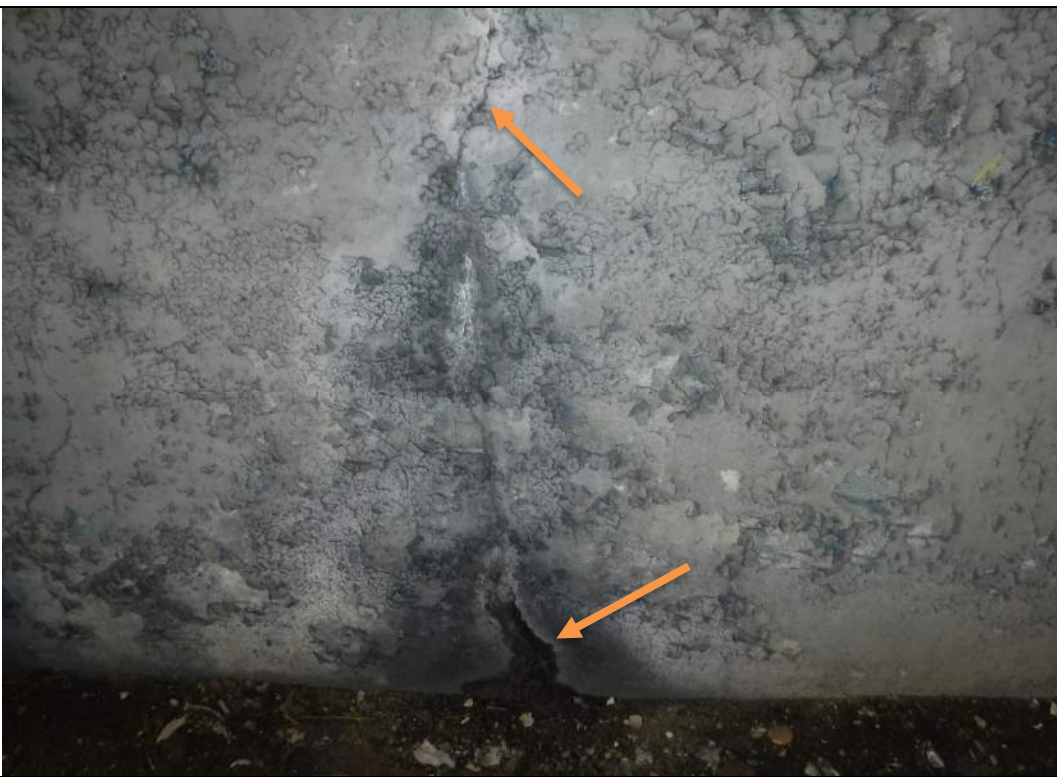
Both abutments are still in fair condition and fully functional. The Begin (West) Abutment exhibits a 1.5 SF hollow area approximately 4 feet above the roadway, multiple full height cracks up to 1/16". The End (East) abutment exhibits multiple hollow areas up to 18 SF, multiple cracks up to full height of the abutment and 1/16" width with heavy efflorescence. (See Photos 4-6)

PHOTO: 4	LOCATION: Begin (West) Abutment 18 feet North of South Fascia DESCRIPTION: Abutment exhibits large crack at ground level with fine Crack that extends full height, Looking West

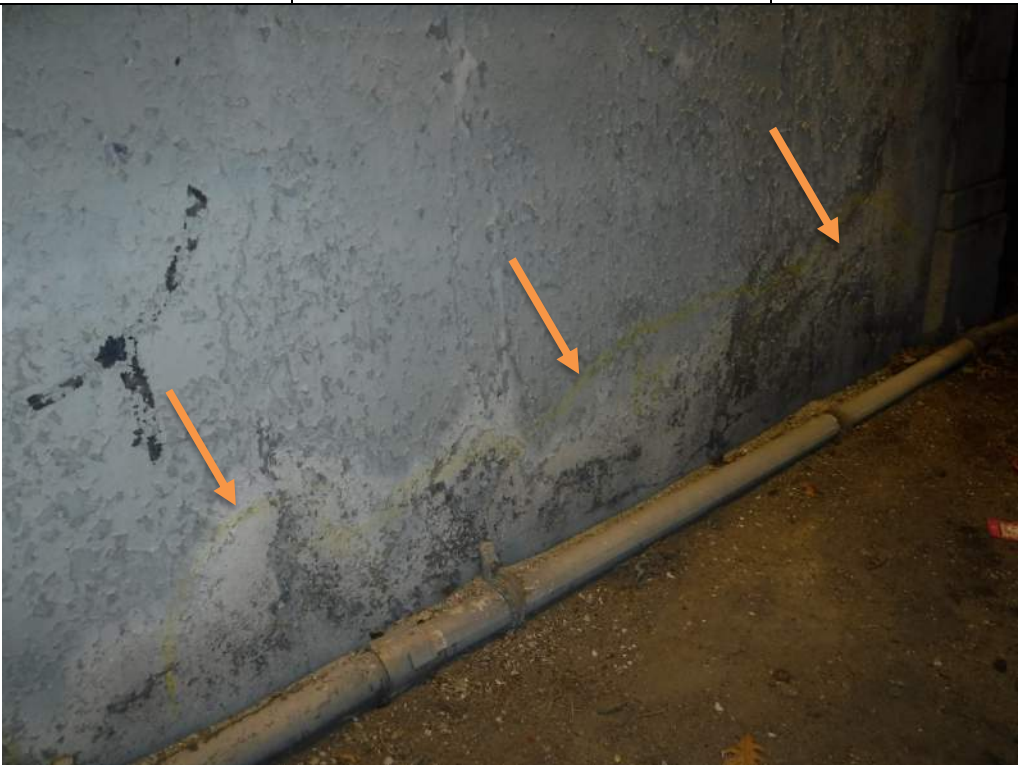
PHOTO: 5	LOCATION: <u>End Abutment near South fascia</u> DESCRIPTION: <u>Abutment exhibits 18 SF hollow area at ground level</u> <u>Looking Southeast</u>

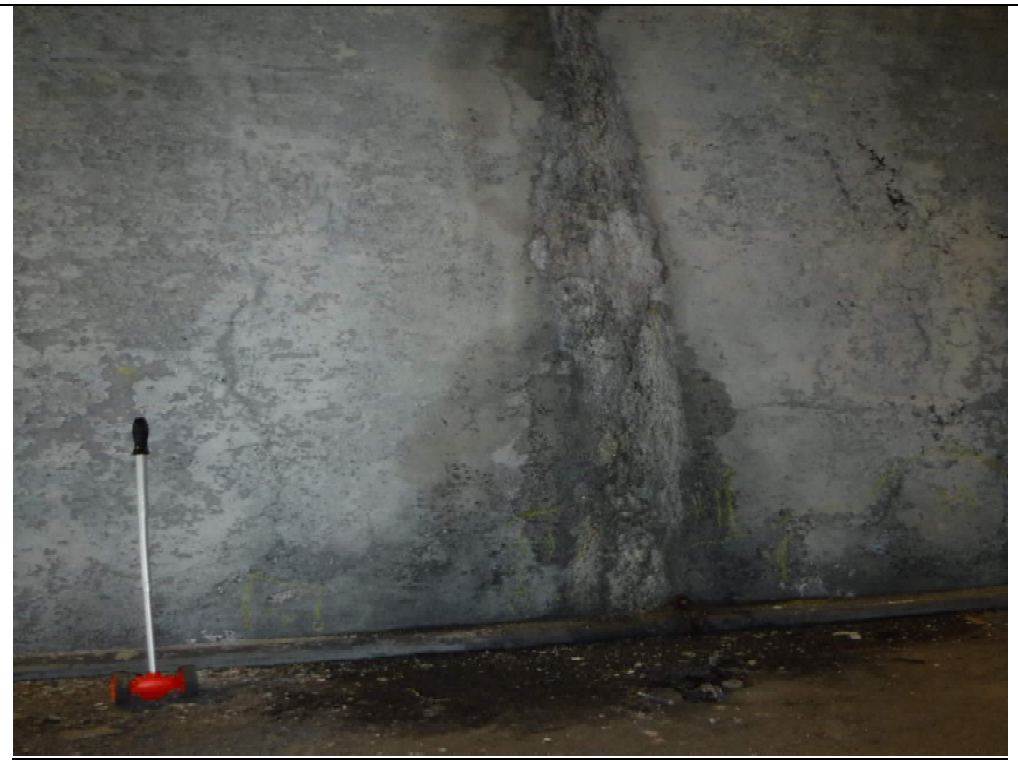
PHOTO: 6	LOCATION: <u>End Abutment 12 feet North of South fascia</u> DESCRIPTION: <u>Abutment exhibits full height crack with heavy efflorescence</u> <u>Looking East</u>

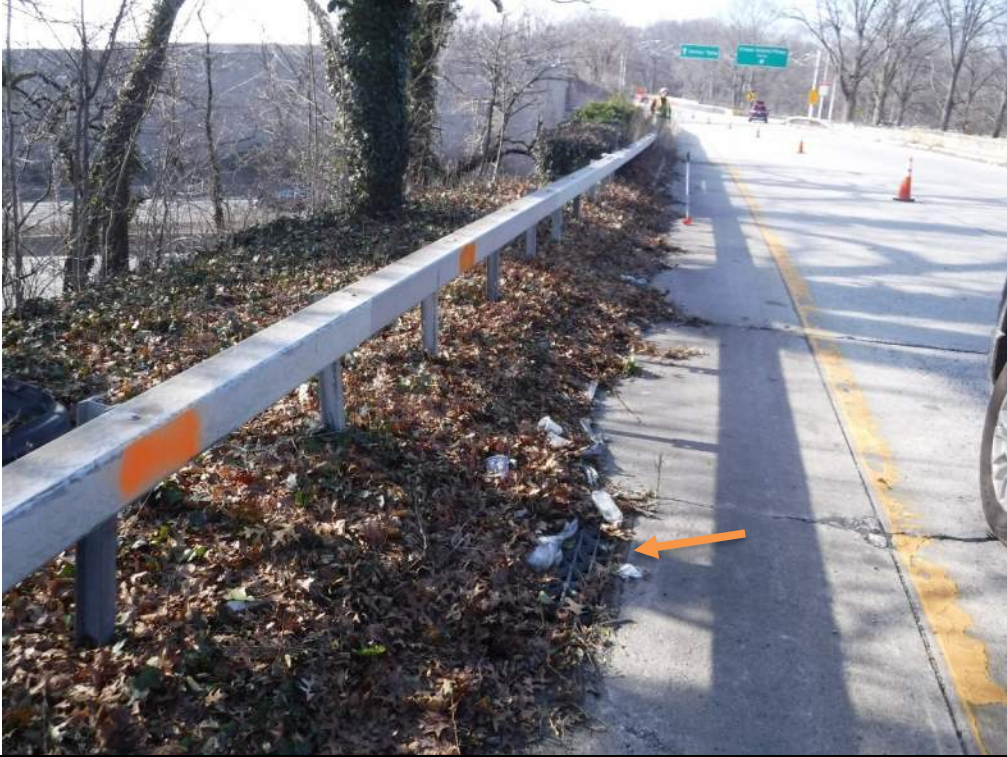
One drainage catch basin exist along the Southside of the End approach approximately 73 feet East of End joint. Catch basin appears open with heavy debris in area. (See Photo 7)

**PHOTO: 7****LOCATION:** Top of deck end approach South side**DESCRIPTION:** Catch basin exhibits heavy debris accumulation
Looking West

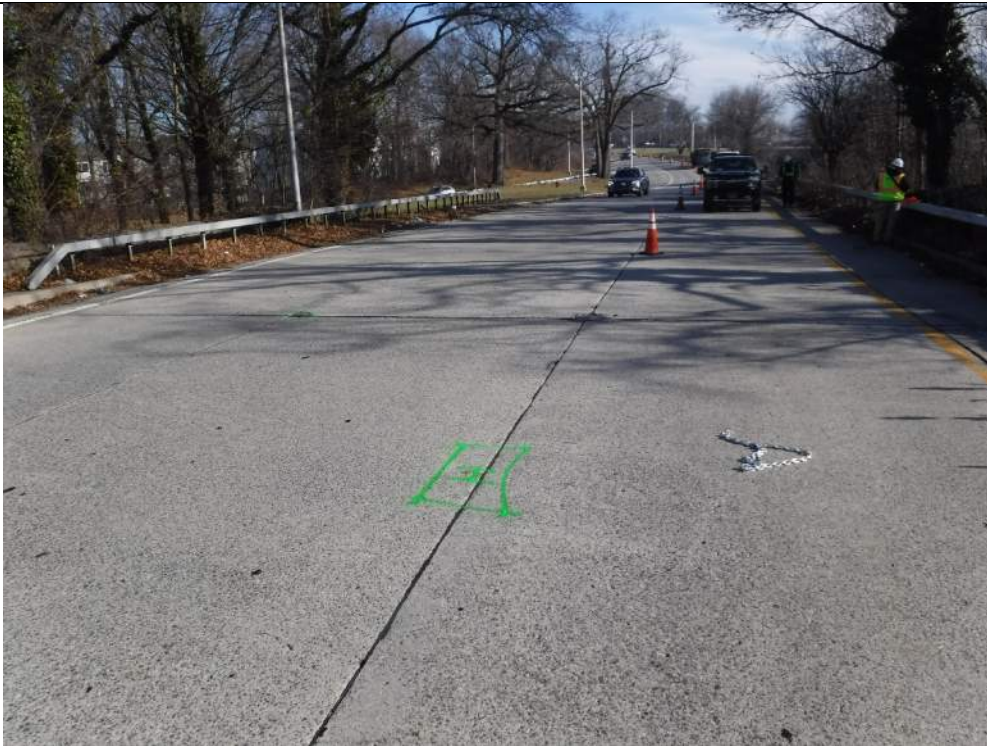
Approach Pavement / Wearing Surface: The asphalt approach pavement exhibits a 2 SF hollow section in the left lane approximately 54.5 feet East of the End joint, a 2 SF hollow area between the left and center lane and a 2 SF hollow area between the right and middle lane both at the End joint, a 3 SF hollow Area between the left and middle lane approximately 15 feet West of the End joint, a 3.5 SF hollow area between the right and center lane approximately 19 feet East of the end joint, a 2 SF hollow area between the right and middle lane approximately 12 feet East of Begin joint, and a 1 SF hollow area between the right and center lane at the Begin joint. (See Photos 8-9)

**PHOTO: 8****LOCATION:** Top of deck End approach 15 feet West of End joint**DESCRIPTION:** Wearing surface exhibits 3 Sf hollow area between left and
Center lane, Looking East

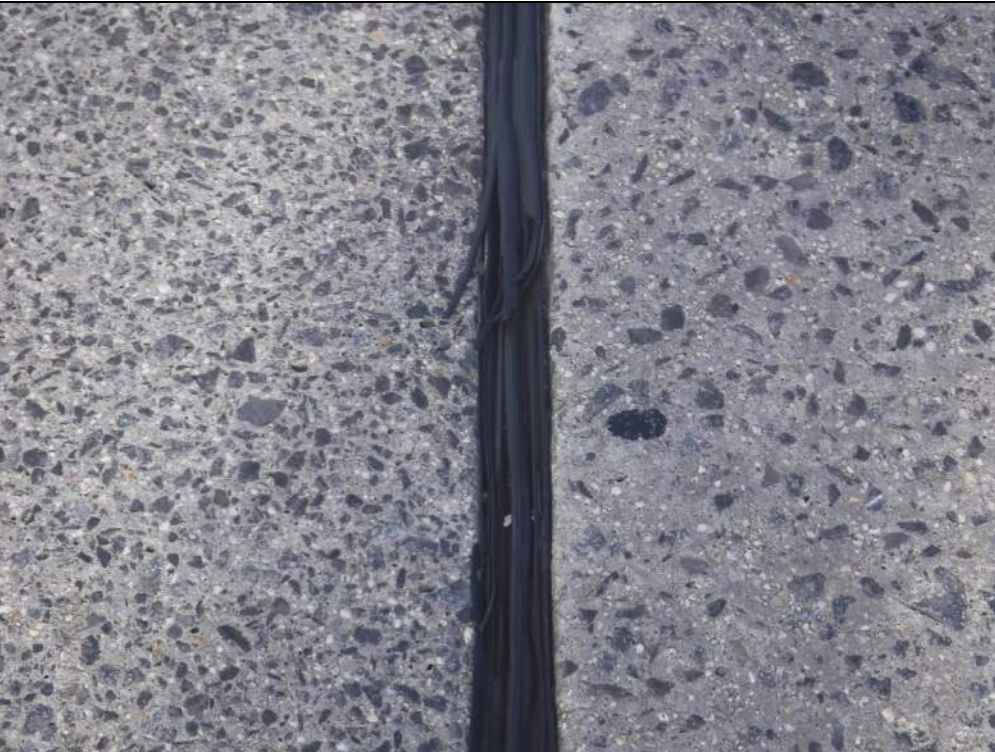
Joints: The joint filler on the Begin, middle and End joint is beginning to dry out, deteriorate and fray. The filler in the North parapet exhibits large holes and missing joint filler. (See Photos 10)

PHOTO: 10	LOCATION: End joint near left lane DESCRIPTION: Joint filler exhibits fraying and deterioration along joint Looking North

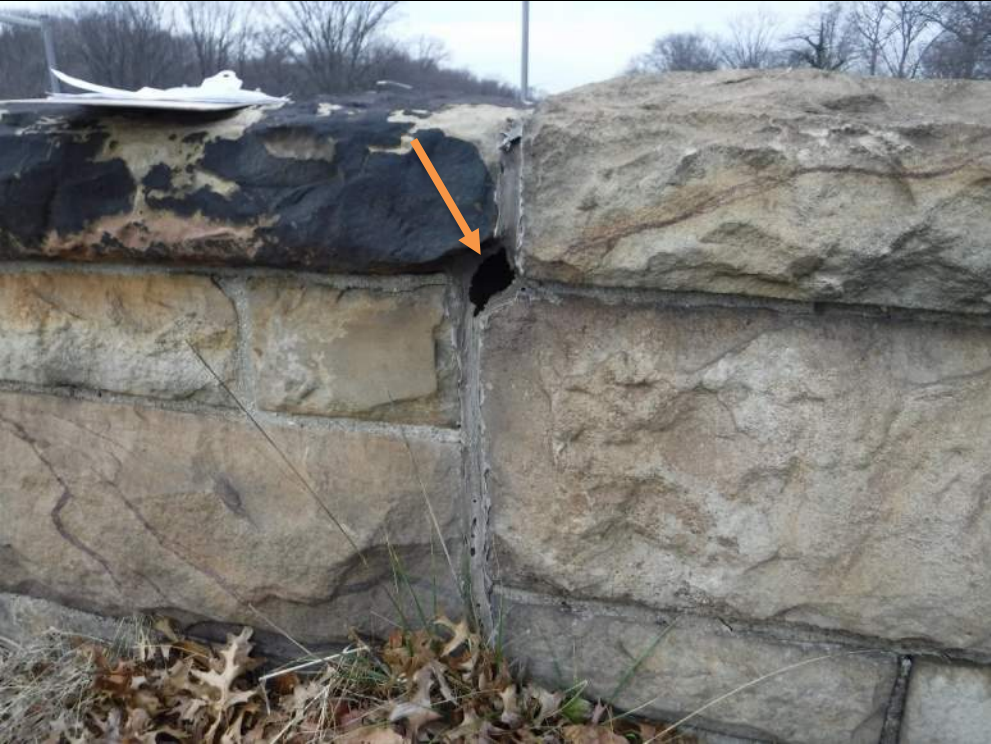
Parapets/Railings: The parapets are in fair condition with multiple areas of stone wearing away and areas where pointing is missing up to 10 in length and 5 inches in depth. All signs of railing post impact and have been replaced/ repaired since last inspection. (See Photo 11)

PHOTO: 11	LOCATION: <u>North Parapet at Begin joint</u> DESCRIPTION: <u>Parapet exhibits up to 4-inch loss of joint filler</u> <u>Looking North</u>

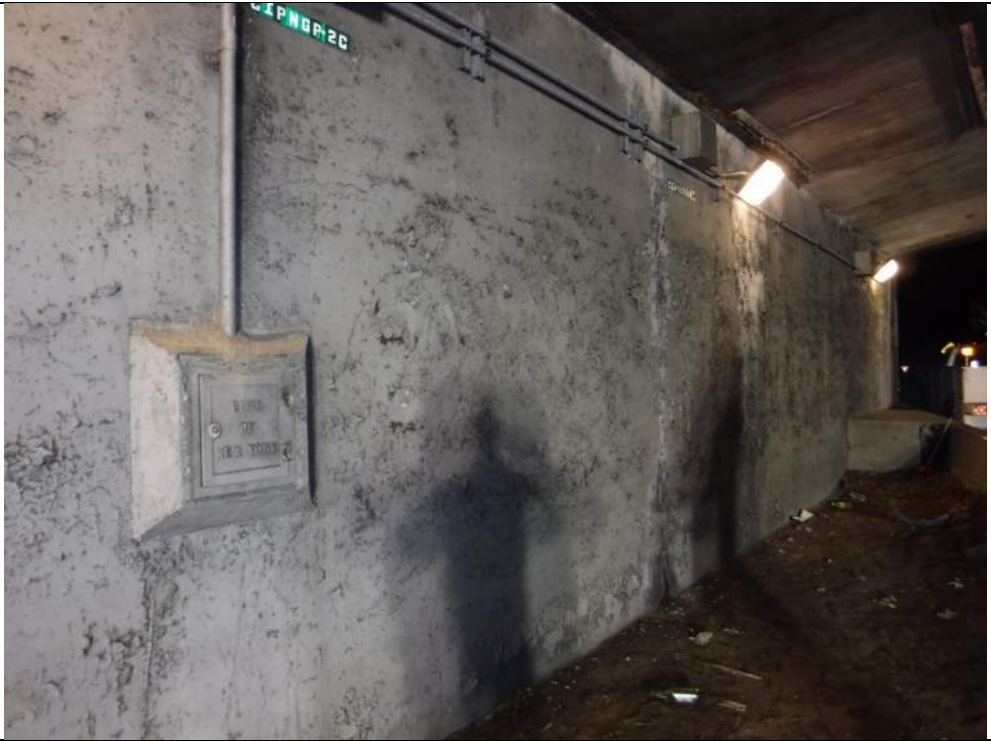
Paint: Paint peeling was noted on the face of the abutments. Paint peeling and paint loss is exhibited over approximately 70% of abutment face. (See Photo 12)

PHOTO: 12	LOCATION: <u>Begin Abutment</u> DESCRIPTION: <u>Abutment exhibits paint peeling and paint loss</u> <u>Looking Northwest</u>

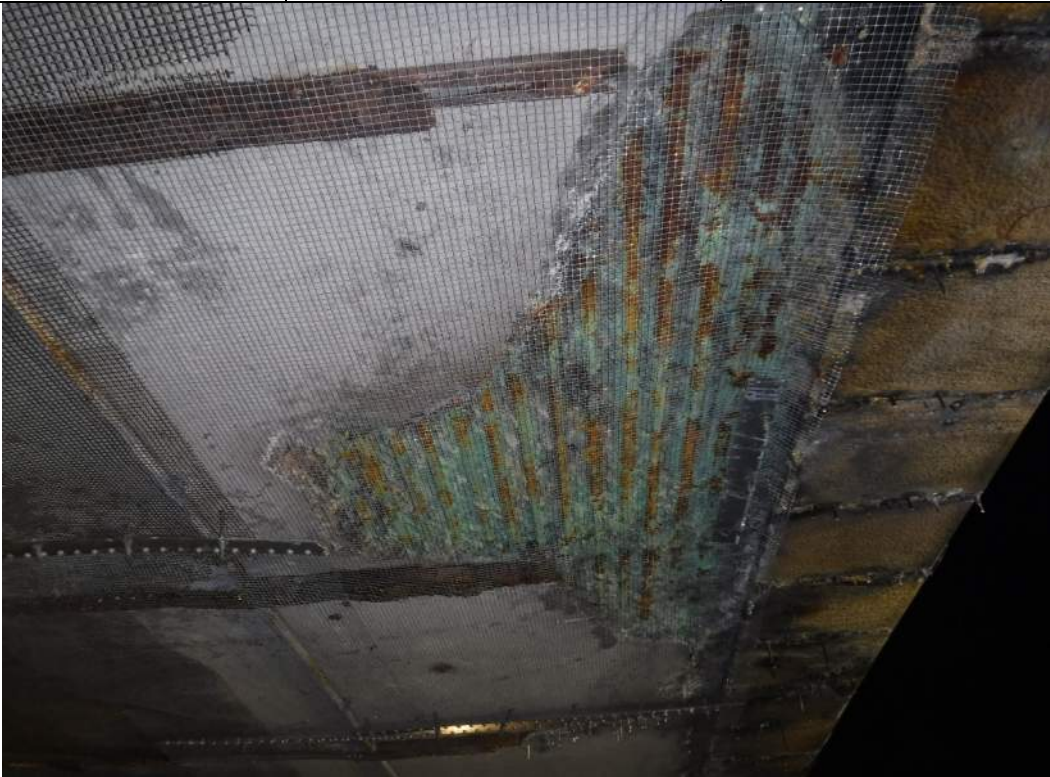
Underside of Arch: Approximately 70 percent of the Underside of the bridge is covered by steel frame shielding. New steel framing and connection have replaced a majority of the old, deteriorated steel mesh and steel mesh connections. The underside exhibits a 32 SF spall with exposed rebar near midspan of the South face, rebar exhibits slight deterioration (less than 10% section loss), spall has been covered with new steel mesh to protect traffic below, a 24 SF hollow area approximately 27 feet East of Begin (West) abutment and 7 feet South of North fascia, a 5 SF hollow area approximately 10 feet South of the North fascia and 6 feet East of the Begin (West) abutment, a 4 SF hollow area 3 feet South of the North fascia and 1 foot East of the Begin (West) abutment, a 4.5 SF hollow area at midspan approximately 33 feet East of the Begin (West) abutment and 6 feet South of the North fascia, and a 6 SF hollow area approximately 13 feet West of the End (East) abutment and 4 feet South of the North Fascia. Underside of North Fascia exhibits heavy accumulation of efflorescence. (See Photos 13-16)

PHOTO: 13	LOCATION: <u>Underside of bridge mid span near South fascia</u> DESCRIPTION: <u>Underside of deck exhibits 32 SF spall with exposed rebar</u> <u>New metal mesh was installed over spall, Looking East</u>

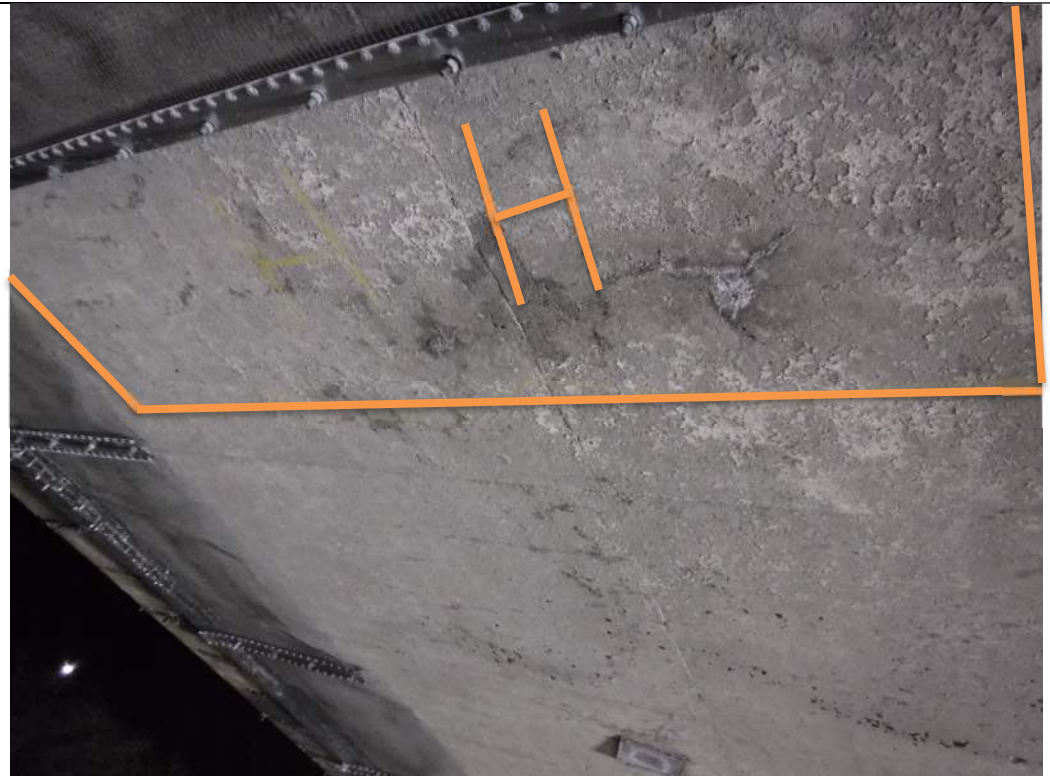
PHOTO: 14	LOCATION: <u>Underside of deck 27 feet East of Begin abutment</u> DESCRIPTION: <u>Underside of deck exhibits 24 SF Hollow area near North</u> <u>Fascia, Looking Northeast</u>

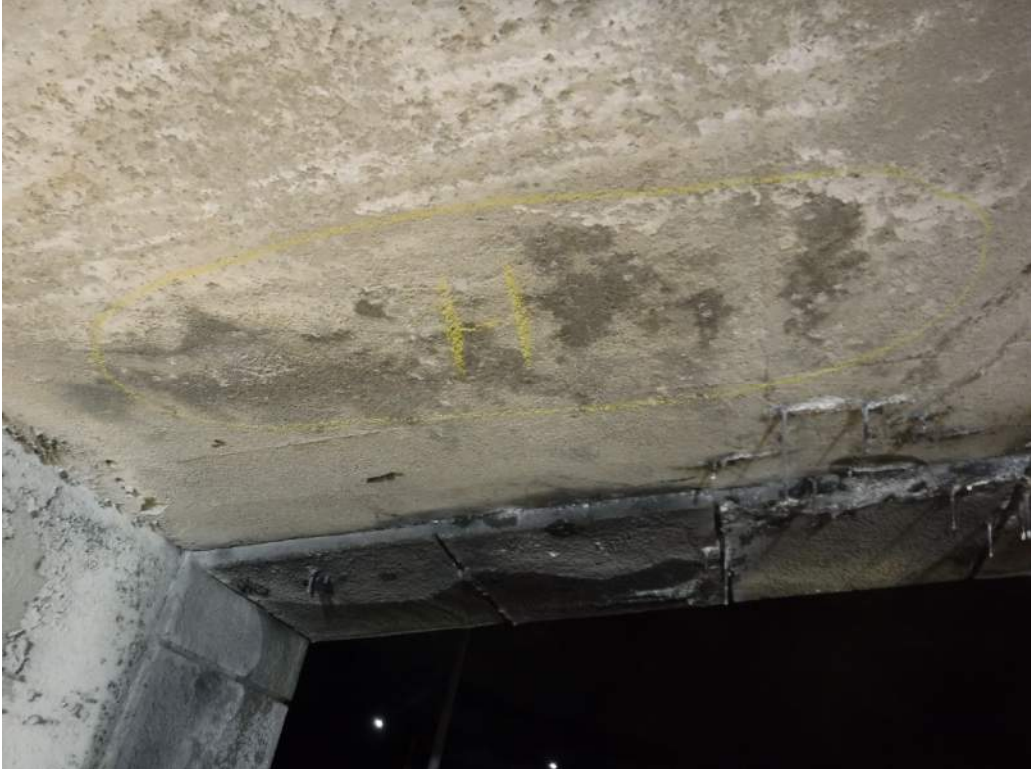
PHOTO: 15	LOCATION: <u>Under side of deck near Begin abutment and North fascia</u> DESCRIPTION: <u>Underside of deck exhibits a 5 SF hollow area</u> <u>Looking North</u>

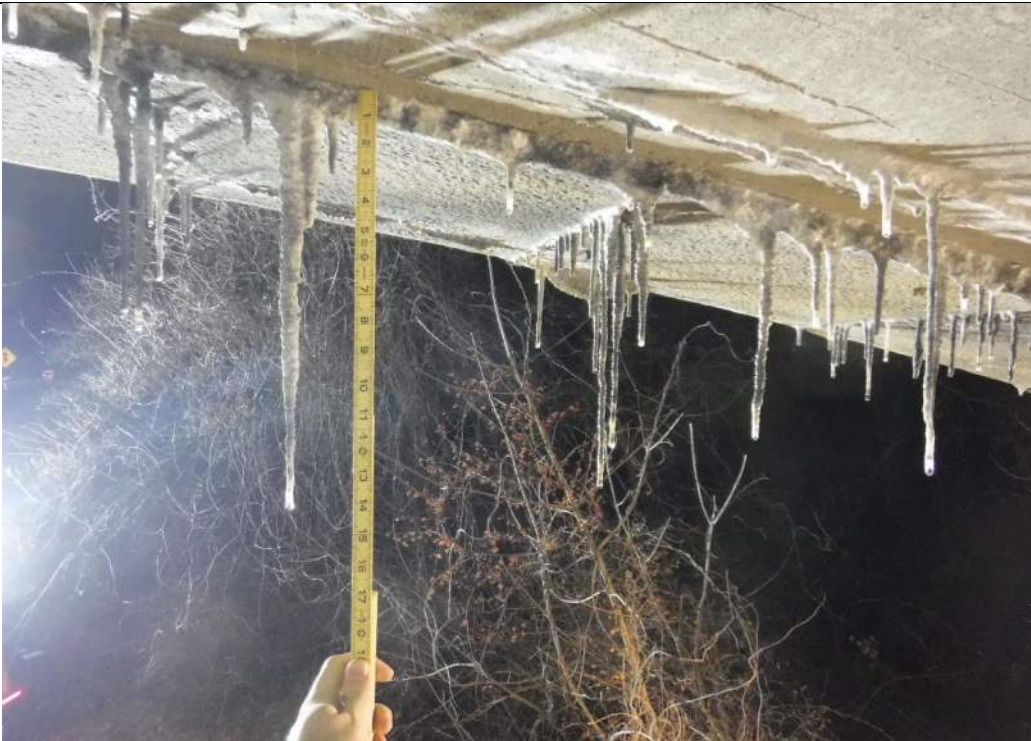
PHOTO: 16	LOCATION: <u>Underside of North Fascia near End abutment</u> DESCRIPTION: <u>Underside of fascia exhibits heavy efflorescence up to 14-inch</u> <u>Looking Northeast</u>

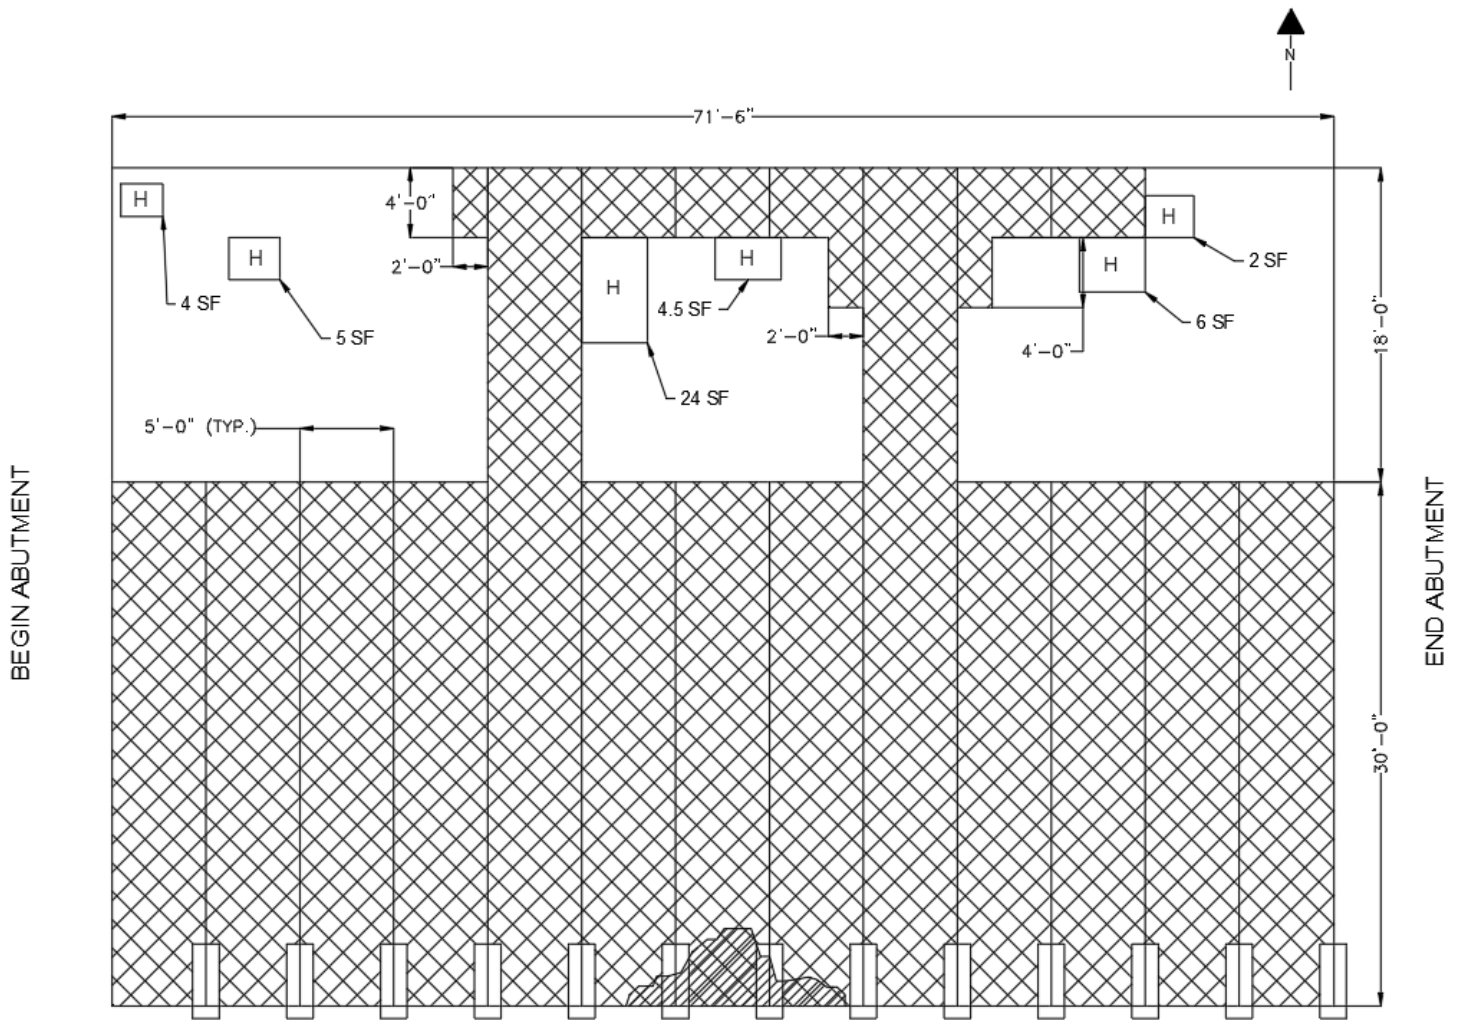
STRUCTURAL ARCH CONDITION

See the Arch Condition Sketch in Appendix A, for detailed locations of deck spalling, cracking and other deterioration.

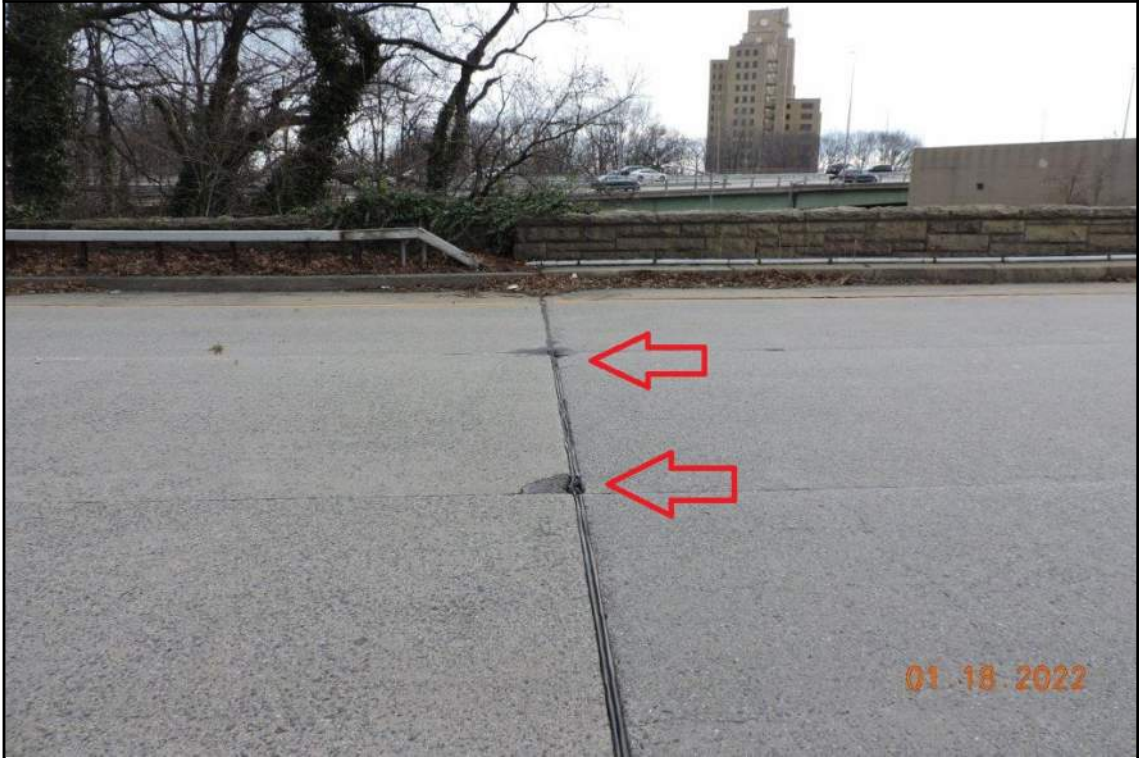
Photo Number: 5 Photo Filename: 22SH0118_6513.jpg

Span 1: BA321 - Reinforced Concrete Approach Slab	TQ	CS-1	CS-2	CS-3	CS-4	CS-5
	1320	1187	132	1	0	0
Condition State 3 Note Referenced Photo(s): 5 Referenced Sketch(es): None						
The Begin Approach Slab exhibits a 1 SF area of uneven asphalt patching in the center lane. Also, the construction joint exhibits slight deterioration of the sealer material, however, the riding quality is good.						
Span 1: EA321 - Reinforced Concrete Approach Slab	TQ	CS-1	CS-2	CS-3	CS-4	CS-5
	2300	2069	182	49	0	0
Condition State 3 Note Referenced Photo(s): 5 Referenced Sketch(es): None						
The End Approach Slab exhibits two 1/2 SF x up to 1" deep spalls (partially patched with asphalt) near the End abutment and a 1/2 SF x 1" deep spall at the end of the end approach slab, all near the center of the roadway. Also, near the end of the End approach slab there is a full width x up to 1/8" wide transverse crack.						
Span 1: 334 - Masonry Bridge Railing	TQ	CS-1	CS-2	CS-3	CS-4	CS-5

Attachment Description:
Location: End Approach
construction joint; Looking
Right. Uneven asphalt
patches. (Typical)

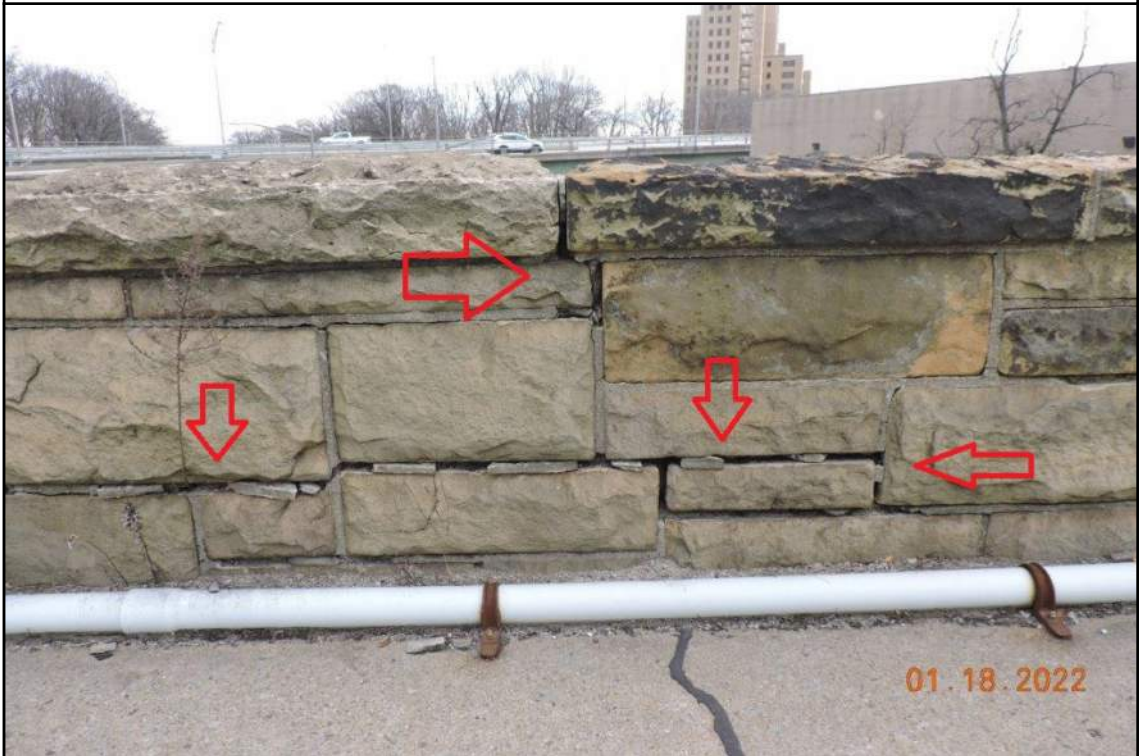
Photo Number: 6 Photo Filename: 22SH0118_6510.jpg

146	73	48	25	0	0
Condition State 3 Note Referenced Photo(s): 6 Referenced Sketch(es): None						
The interior face of the right masonry bridge railing near the Begin is missing approximately 25% of its pointing for a length of 25 LF (photo 6).

Attachment Description:
Location: Span 1 Right
Masonry Bridge Railing
near Begin Abutment;
Looking Right. Missing
pointing.

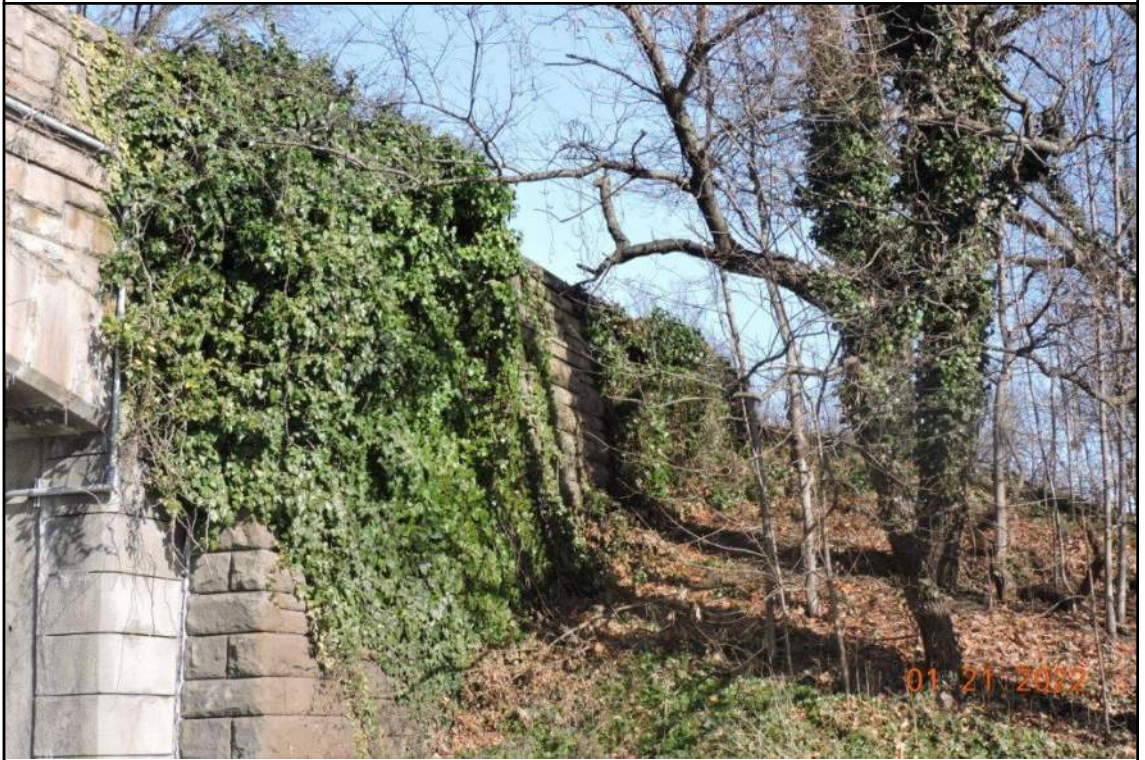
Photo Number: 9

Attachment Description:
Location: Right End
Wingwall, vegetation
growth, looking toward End
Left (typical).

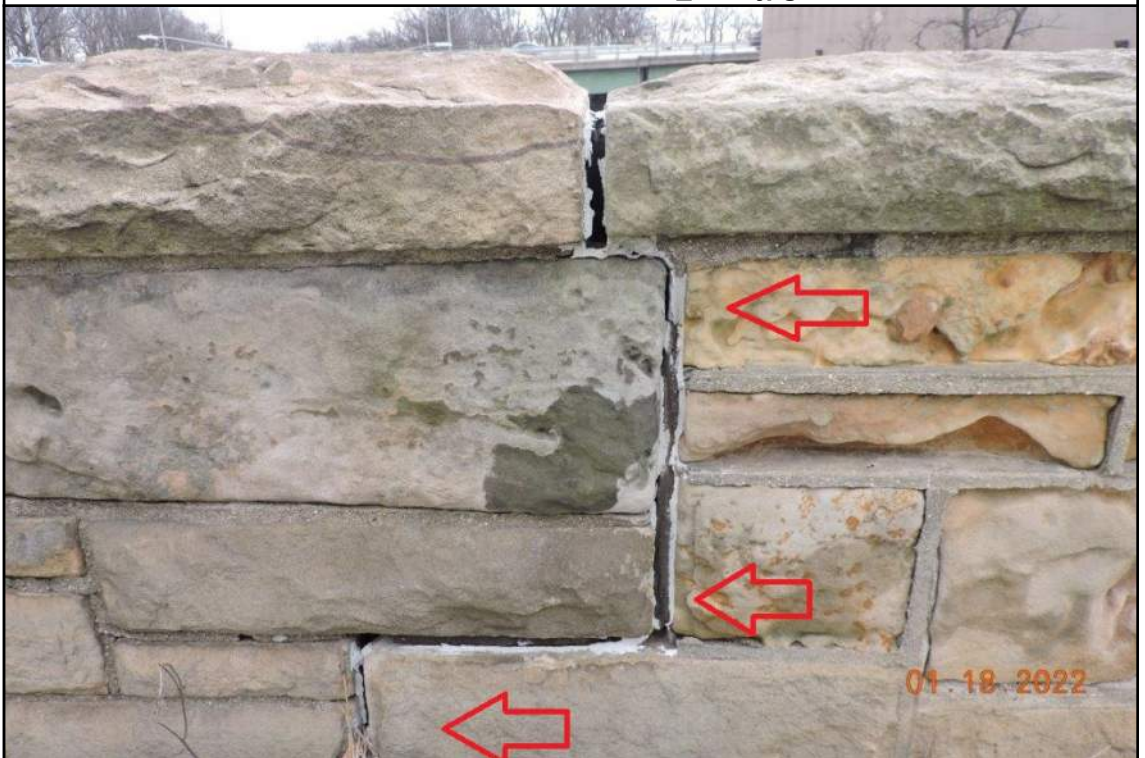
Photo Number: 10

Attachment Description:
Location: Right side Begin
approach railing, missing
pointing, looking right

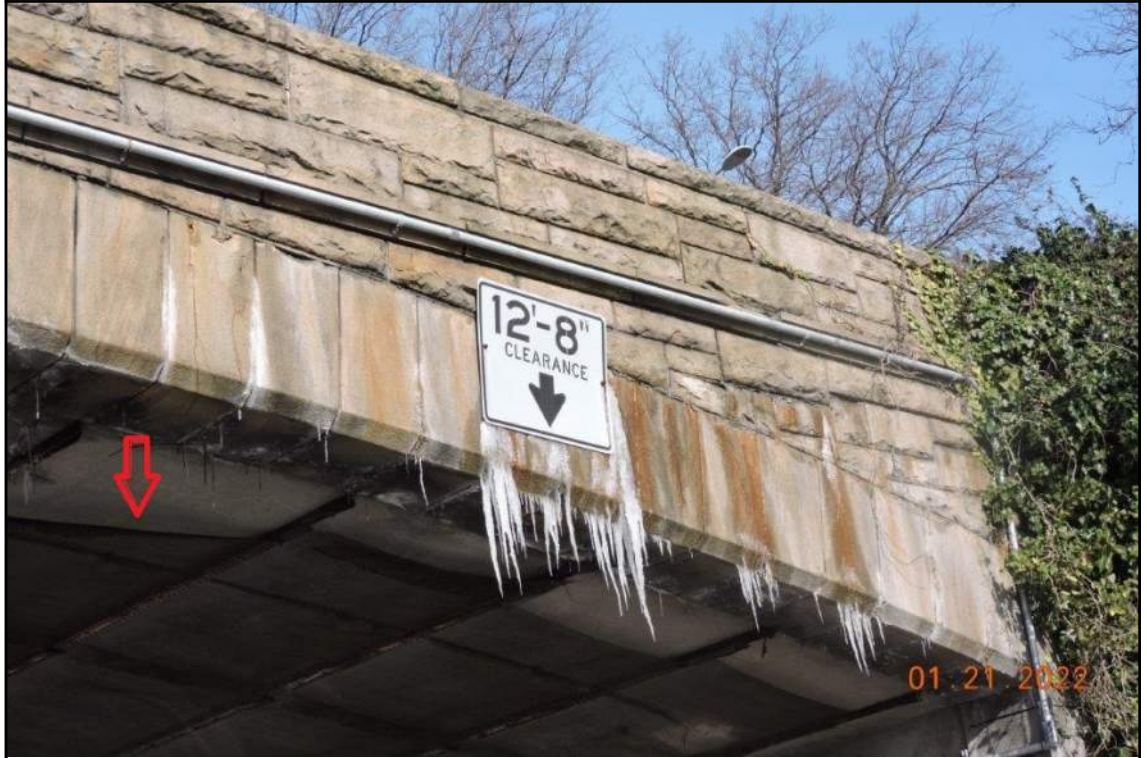
Photo Number: 11

The wire mesh shielding and steel supports exhibit minor surface corrosion, but are mostly secured in place. However, all the steel shielding supports along the right edge exhibit heavy corrosion and pack-rusted components for up to 5' long with various locations of detached mesh shielding up to 5.2' long for approximately 124 SF total.

Location: Span 1 Right
railing, water leaking from
missing pointing areas and
deteriorated wire mesh,
looking toward End Left.
Ref. NSCO issued for
deteriorated wire mesh

Repair steel shielding supports on the right sides and hole in the wire mesh netting. See sketch for locations.

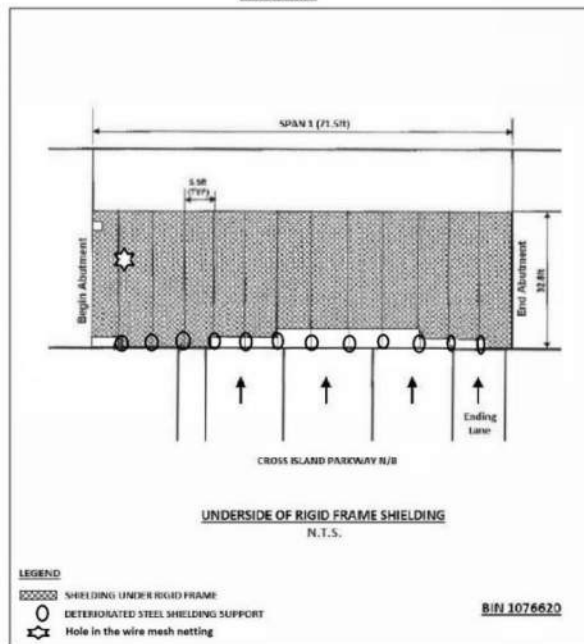
Sketch Number: 5

COMMENT The wire mesh shielding is attached to the underside of the concrete rigid frame by transverse steel supports, typically space 5' 6" on center. The wire mesh shielding and steel supports exhibit minor surface corrosion, but mostly secured in place. However, all the steel shielding supports along the right edge exhibit heavy corrosion and rack-rusted components for up to 5' long. These locations exhibit detached mesh shielding up to 6' long for approximately 124 SF area in total. There is a hole in the wire mesh netting by Begin abutment, measuring approximately 2 SF. A NSCO report was issued for the above conditions.
